Home Survival in Wildfire-Prone Areas: Building Materials and Design Considerations

STEPHEN L. QUARLES, UCCE Natural Resources Advisor, Contra Costa County; **YANA VALACHOVIC**, UCCE Forest Advisor, Humboldt County; **GARY M. NAKAMURA**, UCCE Area Forestry Specialist, Shasta County; **GLENN A. NADER**, UCCE Natural Resources Advisor, Sutter-Yuba Counties; and **MICHAEL J. DE LASAUX**, Natural Resources Advisor, Plumas-Sierra County

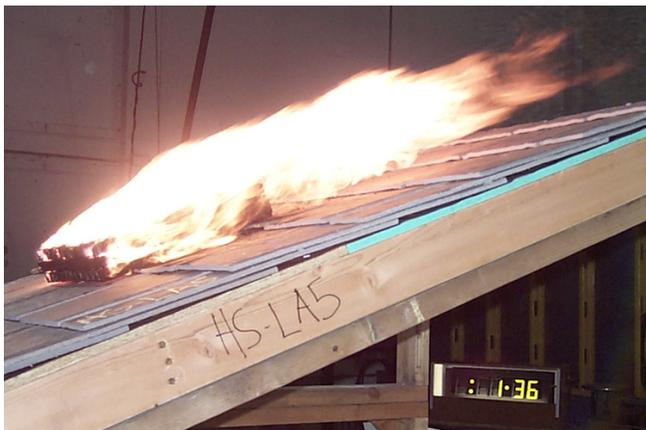
Figure 2. A burning *Class A brand* is positioned on a roof covering, constructed according to ASTM E-108. The *Class A brand* is a three-layer sandwich construction assembled using $\frac{3}{4}$ -inch square sticks, each 12 inches long, made of Douglas fir. The brand is ignited prior to placement on the roof and it is used to produce a standard amount of heat to the roof. Photo: Stephen L. Quarles.

potential of the roof covering. If flame spread is too large, or if fire penetrates through the roof covering and underlying construction materials, the covering cannot be considered Class A. Shown in figures 2, 3, and 4 are a burning *Class A brand*, a *burn through* (i.e., failure), and a gypsum-fiberglass material used in a Class A roof assembly.

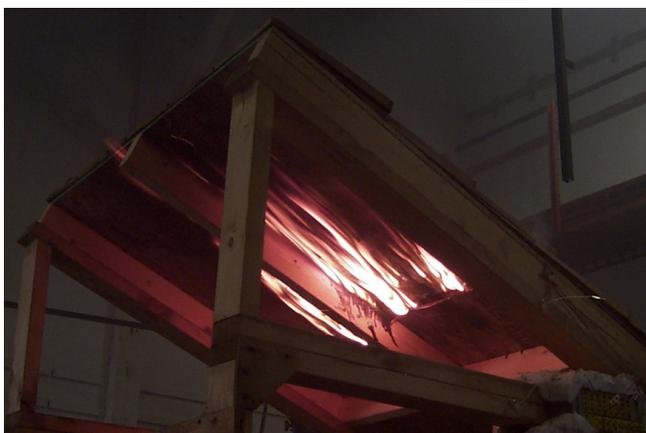
Figure 3. Demonstration of a flame-through (burn-through), passing from the roof covering to the underside of the roof deck. As constructed, this is not a Class A roof covering because it allowed flame penetration when subjected to a Class A burning brand. Photo: Stephen L. Quarles.

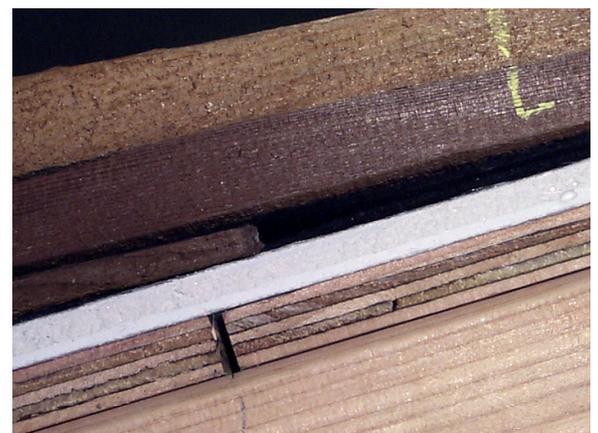
Figure 4. An assembly-rated Class A roof covering, consisting of exterior-rated, pressure-impregnated, fire-retardant treated shakes and an underlying fiberglass-reinforced panel (white in color). Note that the joints between the gypsum and wood sheathing panels are staggered. This minimizes the opportunity for fire to penetrate into the attic space. Photo: Stephen L. Quarles.

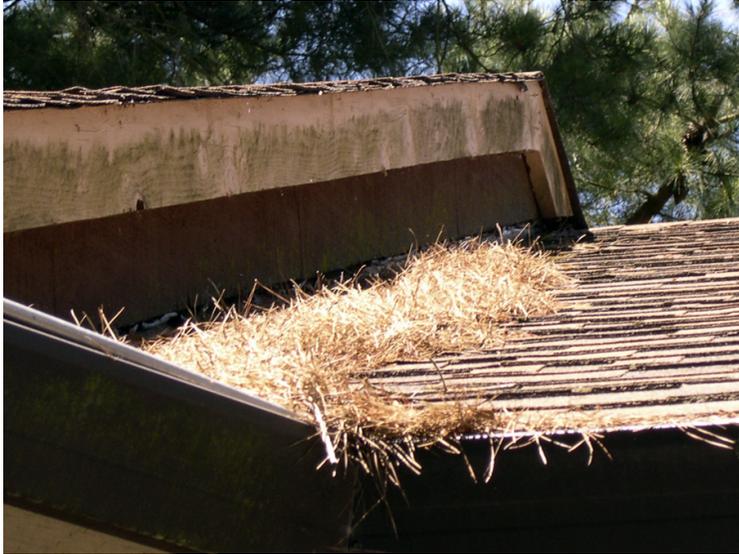
Figure 5. Vegetative debris accumulated at this roof-to-wall intersection. Ignition of this debris would expose the adjacent siding to flames, as well as the underlying sheathing above this stand-alone Class A roof covering. Depending on the overall roof design, the Class A roof covering could give the homeowner a false sense of security. *Photo:* Stephen L. Quarles.

A complex roof provides an additional level of vulnerability. The term *complex* indicates that there are a number of horizontal-to-vertical intersections on the roof that could make a Class A roof more vulnerable to wildfire, and in particular to an ember exposure. From a fire performance perspective, these intersections provide collection points for windblown debris (e.g., pine needles and other vegetation), debris from overhanging trees, and—during a wildfire—windblown embers. These locations are also where different construction materials with different fire vulnerabilities will be present on the respective surfaces. If ignited, the flames from the burning vegetative debris would provide a flame contact exposure on the siding material, the roof sheathing or soffit material, or even a window. The vulnerability of these components will depend on material selection and other design considerations. Particularly with a Class A roof, it will be the fire resistance of the siding, sheathing, or window that will determine the vulnerability of the complex roof, not the roof covering itself. Examples of two complex roof features that can increase the vulnerability of a complex roof are given in [figures 5 and 6](#).

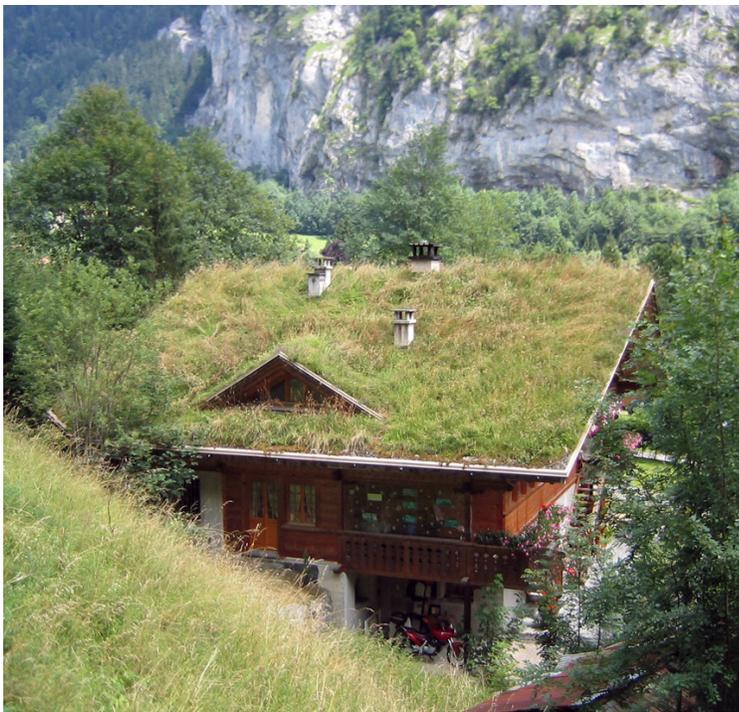
Figure 6. This vegetative (green) roof covering provides Class A protection in terms of fire penetration into the attic or living space, but ember ignition and subsequent flame spread and contact with the dormer and window shown in this photograph could result in the glass breaking and fire entering the building. *Photo:* Bernard Harrison.

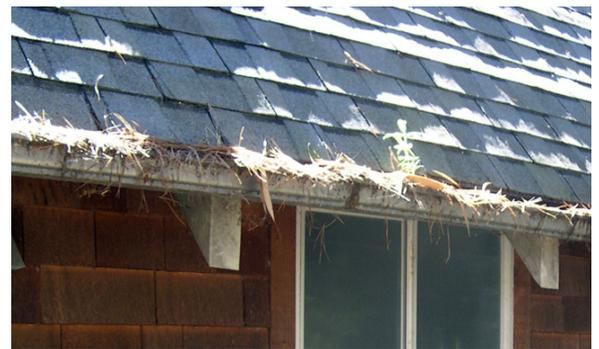
Figure 7. Note the heavy needle accumulation in this metal gutter. If ignited by embers, flames would impinge on the roof edge, potentially igniting the roof sheathing. Because of the open eave construction (i.e., exposed rafters), the fire would not immediately enter the attic or cathedral ceiling space. If ignited, the wood shingle siding and plywood skirting also shown in this photograph would threaten the home via a flame contact exposure to the single-pane window and the under-eave area. The ignited shingle siding could also burn into the stud cavity and into the living space of the home. *Photo: Stephen L. Quarles.*

When ignited by embers, the burning debris in the gutter will provide a flame contact exposure to the edge of the roof (fig. 7). The protection provided by the roof edge must be sufficient to resist the entry of flames into the attic space or cathedral ceiling. The roof edge must also protect against the ignition of the exposed roof sheathing or the exposed fascia board. The exposure is more severe if metal angle flashing is not used at the roof edge and if the gutter is hung below the roof edge, leaving the roof sheathing exposed.

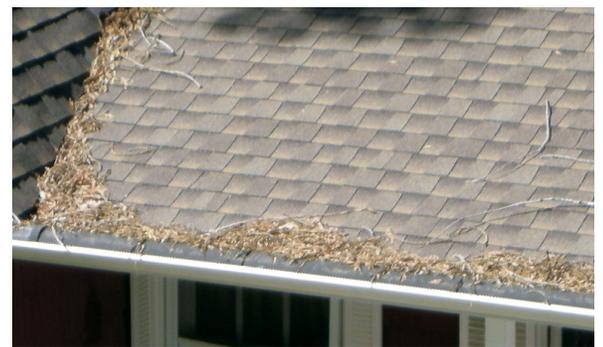
Figure 8. Debris accumulation behind a gutter cover device. The gutter is clear of debris, but the roof still should be cleared of debris. Photo: Stephen L. Quarles.

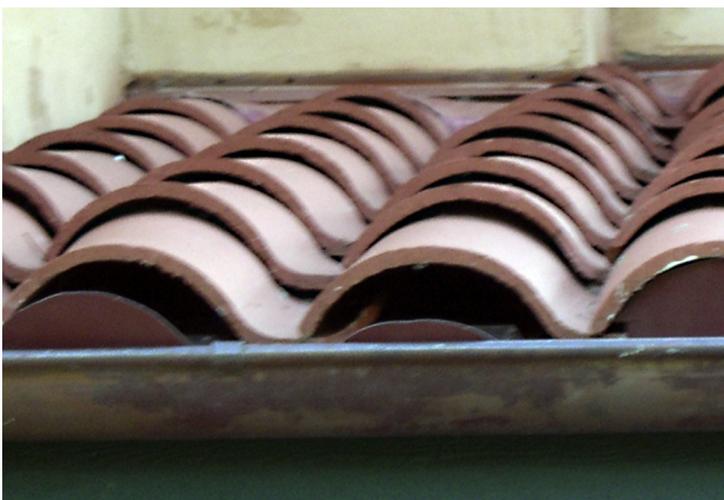
Figure 9. Two of the three visible bird stops shown in this clay barrel tile roof covering have been improperly installed or have become detached. Inspection of these should be part of a regular (annual) inspection and repair plan. *Photo:* Stephen L. Quarles.

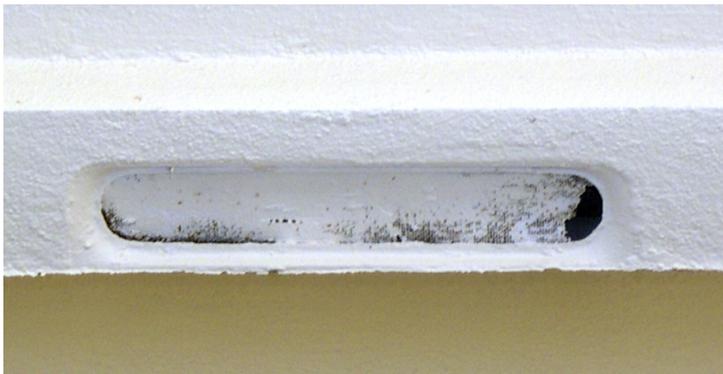
Figure 10. Paint easily bridged the gaps in this $\frac{1}{16}$ -inch mesh screen, reducing the effectiveness of this vent to allow air flow. Note that the screen has become detached from the substrate on the right-hand side. Embers could easily enter through this gap. *Photo:* Stephen L. Quarles.

airborne debris or painted over (fig. 10), thereby compromising the vent's moisture management function; however, somewhat finer mesh screening may eventually be allowed by the building code. Even though finer mesh screening uses wire with a smaller diameter, the total amount of void space (no wire) is reduced when finer mesh screen is used. For example, assume you have a vent opening that is 1 foot on a side (the area would be 1 square foot). Placing $\frac{1}{4}$ -inch, $\frac{1}{8}$ -inch, and $\frac{1}{16}$ -inch mesh over this opening would reduce the void space by 19 percent, 25 percent, and 29 percent, respectively. With finer mesh screening, a building official may require more vents to obtain the required amount of venting. (For equivalents between U.S. and metric systems of measurement, a conversion table is provided at the end of this publication.)

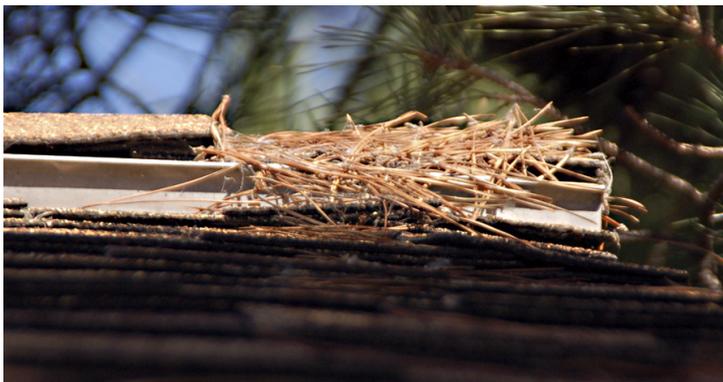
Figure 11. Accumulation of pine needles at the entrance to a ridge vent. *Photo:* Stephen L. Quarles.

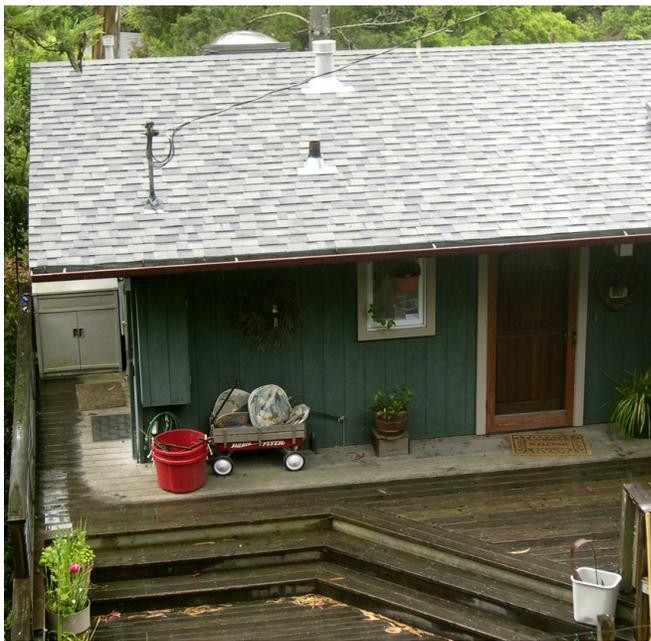
Figure 12. The wide overhang on this home protects the exterior wall from rain. Since many water-related problems in buildings can be traced to leaks at penetrations in the exterior wall (e.g., at windows and doors), limiting exposure would reduce the occurrence of water-related problems. Photo: Stephen L. Quarles.

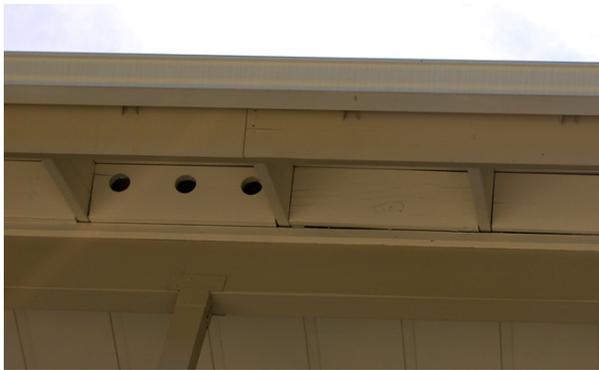
Figure 13. An example of open-eave construction. The roof rafter tails are exposed. The circular frieze-block vents shown here are typically located in the blocking. Note the gaps between the blocking and adjacent framing which would allow ember entry. These gaps could be caulked. Backer rod may be needed for wider gaps. The caulked joints should be inspected annually and failed joints repaired. *Photo:* Stephen L. Quarles.

Two basic types of construction exist for the eave. The first is an open eave design where the roof rafters extend beyond the exterior wall and are visible (fig. 13). Blocking is used to fill the space between the top of the exterior wall and the roof sheathing. If present, vent openings would

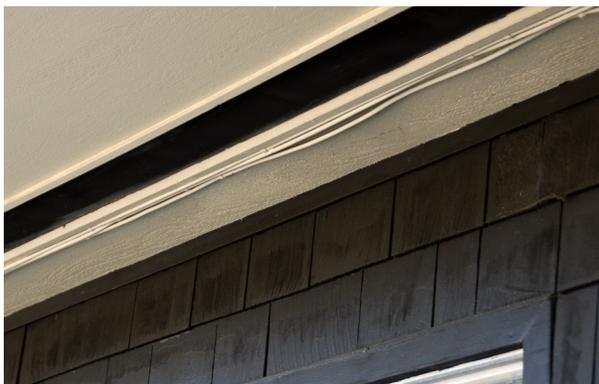
Figure 14. An example of a soffited eave, also sometimes called a *boxed-in* eave. Depending on the vulnerability of the vent, embers could enter into the soffit area. Vertical flame spread up the wall would make flame entry through the vent and into the attic more likely. Moving the vent away from the wall (closer to the edge of the roof) would make flame and ember entry less likely. *Photo:* Stephen L. Quarles.

be cut into the blocking. The second is a soffited construction where the eave is enclosed (fig. 14). This type of construction is also called a *boxed-in* eave, although boxed-in is sometimes reserved for situations where an open-eave design is enclosed, following the slope of the exposed rafters. The vulnerability of an unvented open eave or soffited eave construction will depend on the material and joints. Joints that exist between different pieces of building material are particularly vulnerable in combustible soffit material, and they will usually be the location where the fire would enter. For example, the initial failure in a tongue and groove (T&G) soffit material will either be at the T&G joint or at a knot. A knot or internal void in a plywood soffit material would be the likely failure location (Jennings 2000). Joints would also be the most likely failure location in a noncombustible material.

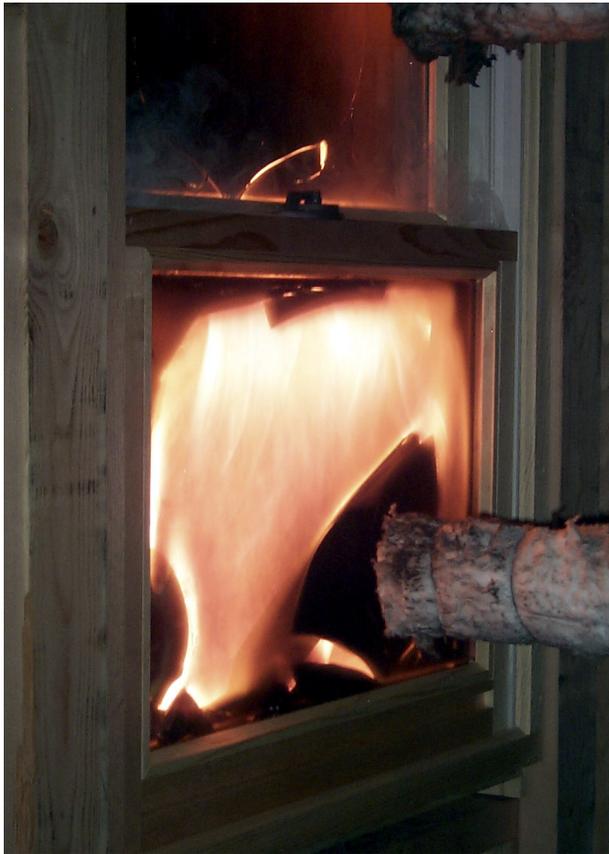
Figure 16. The flame contact exposure during laboratory testing of this wood-frame, dual-pane window resulted in glass breakage. The relatively large pieces of glass that remain indicate that annealed glass was used. *Photo:* Stephen L. Quarles.

There has been conflicting information regarding the relative importance of glass versus frame material when windows are subjected to wildfire exposures (fig. 16). For example, some builder's and homeowner's guides (e.g., Slack 2000; FEMA 2008) do not recommend using vinyl- and wood-framed windows. This recommendation, in part, comes from research by Mowrer (1998), where he reported that certain vinyl-framed windows deform under radiant exposures much lower than that required to break the glass. The window fails when the deformed frame allows the glass unit to fall out completely or allows a gap to develop between glass and frame. This problem can occur with windows that have horizontal or vertical separators in the middle of the window (i.e., a single- or double-hung window or a slider window). Research has shown that as long as

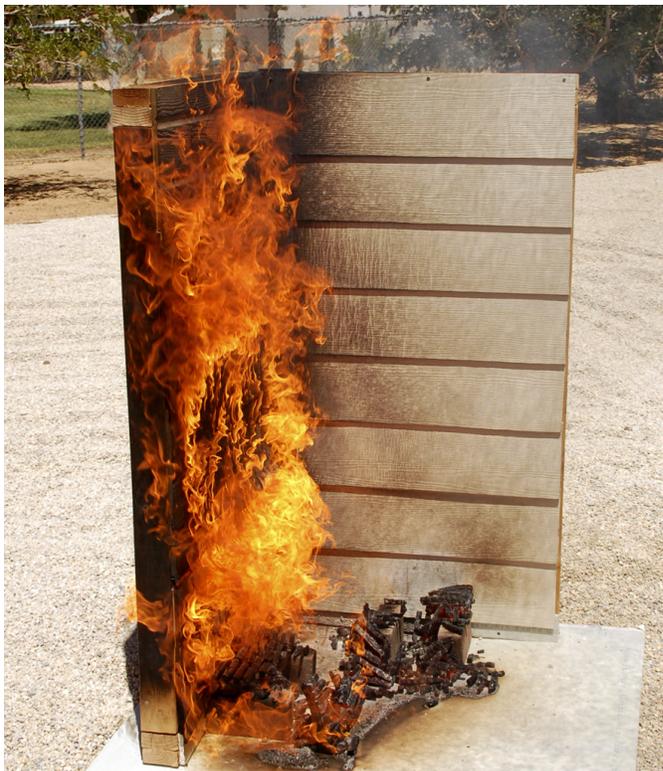
Figure 17. This corner section was constructed with a wood-composite siding material (left side) and a noncombustible fiber cement product (right side). The ignition source for both was a burning brand. The wood-composite siding product was ignited by the ignition source, and the fire then spread up the wall. Flames from the fire would have impinged on windows and eave, if they had been present. The wood brand burned out at the base of the fiber cement siding product without causing significant damage. *Photo:* Stephen L. Quarles.

Testing at the University of California Fire Research Laboratory has shown that, when ignited, compressed wood particle or fiber siding products (see fig. 17) and wood shingle siding will result in more rapid vertical flame spread up the wall, and more rapid penetration through the lap joints and into the stud cavity. Similar results have been observed with vinyl siding. In both of these cases, underlying wood or gypsum sheathing would improve the resistance to flame penetration at a lap joint.

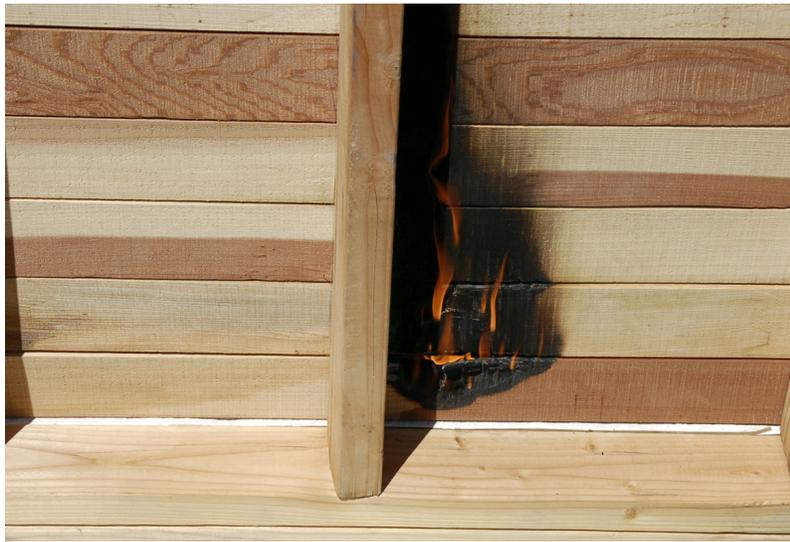
Figure 18. Flame penetration (*burn through*) at the rabbeted bevel lap joint in a solid wood siding product, as viewed from the stud cavity side of the wall. This test was conducted at the UC Fire Research Laboratory. Although a panelized sheathing product is commonly used in construction, it was not used in this test in order to allow viewing of the siding performance. Use of sheathing has been shown to increase the time needed for fire to penetrate into the stud cavity, sometimes to the point of excluding entry altogether. *Photo:* Stephen L. Quarles.
