# Colorado Forestry Best Management Practices

## *Forest Stewardship Guidelines for Water Quality Protection*

**2012 Field Audit Report**

**February 2013**

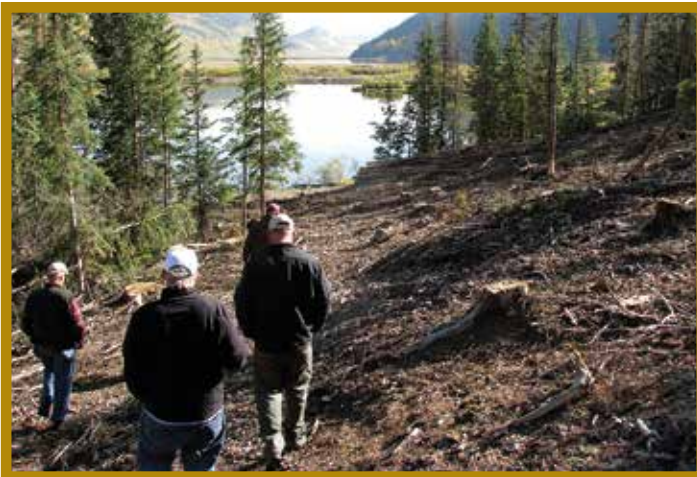
The audit team inspects skid trails and the Streamside Management Zone (SMZ).

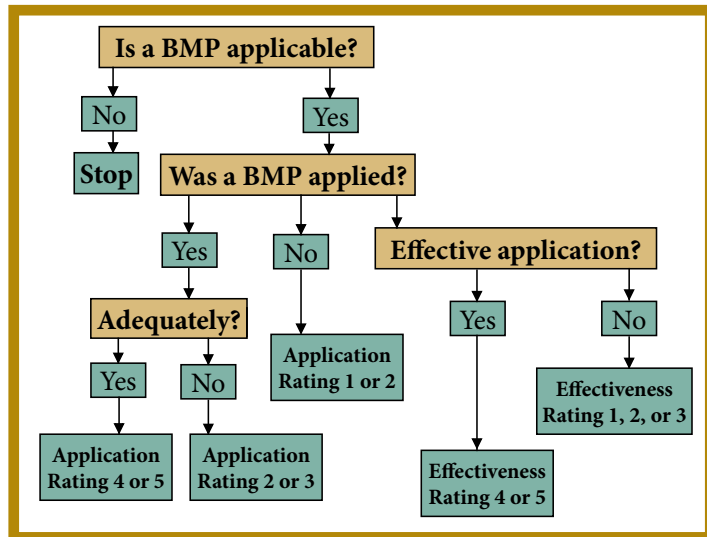
Figure 2: Colorado BMP Audit Ranking System (©CSFS)

The rating process conducted for each BMP begins with establishing whether the BMP in question is applicable to the harvest activities under consideration (Figure 2). For example, not all harvest sites require the construction of temporary roads. In these cases, the BMPs that pertain to temporary roads are not applicable. Once the audit team establishes that a given BMP is applicable, the application rating for the BMP is determined, based on written criteria (Table 1).
